GIM4310-10 BRAKE INSTALLATION DRAWING

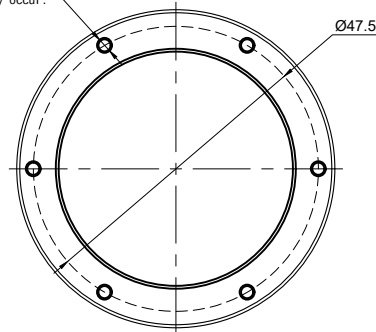
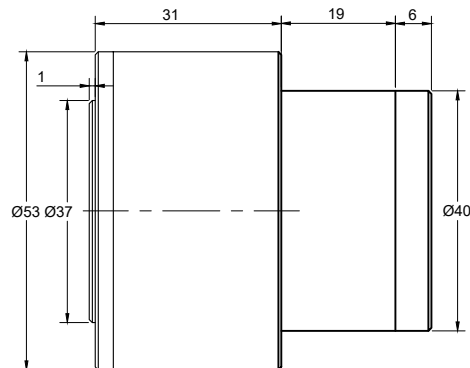
6-M2.5 THREAD DEPTH 3mm,  
Screws must not be excessively long.  
Otherwise, motor damage may occur.

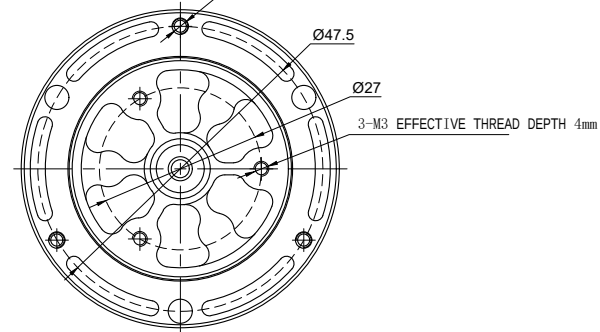
3-M2.5 EFFECTIVE THREAD DEPTH 5mm

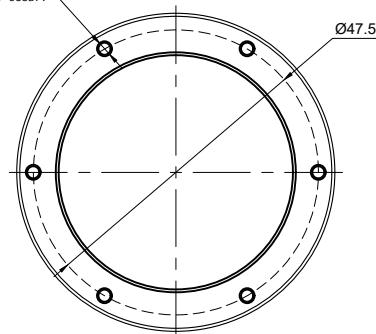
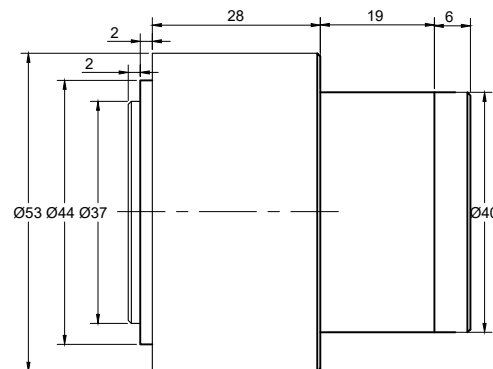
6-M2.5 THREAD DEPTH 3mm,  
Screws must not be excessively long.  
Otherwise, motor damage may occur.

### FRONT COVER OMITTED

The front cover functions to constrain the bearing. The no-front-cover state applies when the motor mounting position can constrain the bearing, used to reduce installation height. This state is an unfinished structure before installation is completed. Do not test run the motor, otherwise there is danger of the rotor coming out.

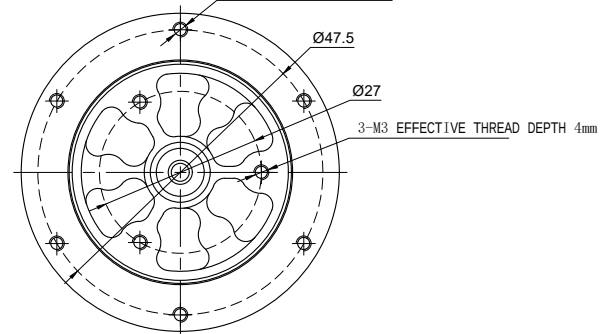
6-M2.5 EFFECTIVE THREAD DEPTH 5mm
